SONY® Service Bulletin

NO: ME3-99-010

SUBJECT: ROTARY ENCODER VOLUME MAY NOT WORK

MODEL (S): MDX-C670/C7900/C8900

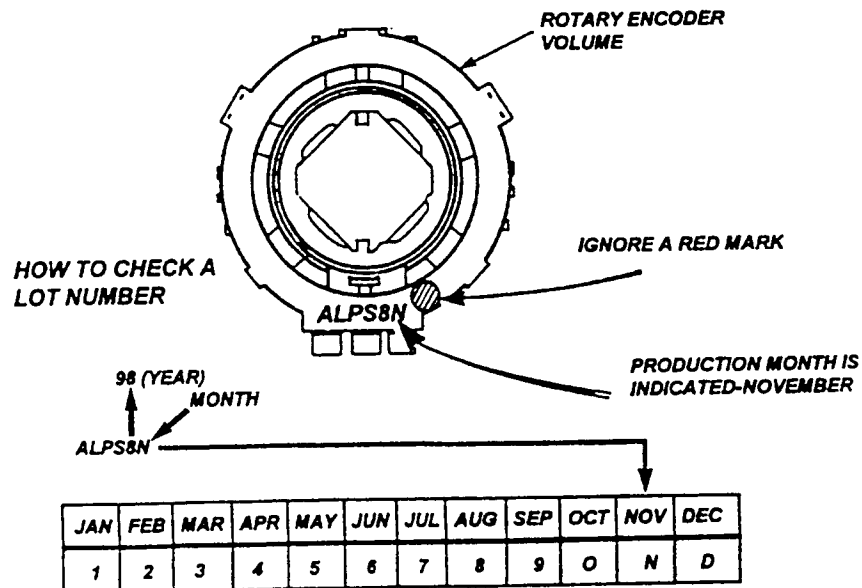
Please use illustration to verify lot number.

SOLUTION: If this condition exists or customer complaint is this symptom then, replace the rotary encoder with an improved one. Please indicate what month and year the encoder was manufactured. All encoders produced before November 1998 are subject to failure.

DESCRIPTION	PART NUMBER
ROTARY ENCODER	1-475-014-12
